NATIONAL ADVISORY COMMITTEE FOR AERONAUTICS.

CAUSES OF FAILURE OF AIRSHIP SHEDS.

I. COLLAPSE OF AIRSHIP SHED A IN NIEDERGORSDORF.

II. SUCTION EFFECTS OF WIND ON ROOF OF AIRSHIP SHED

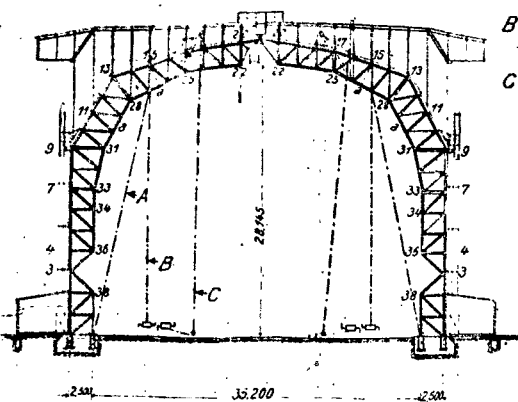
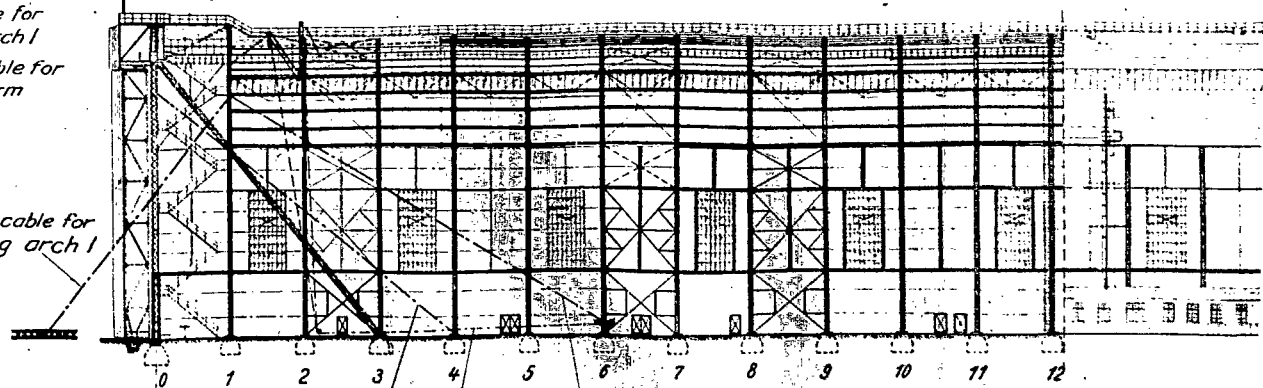
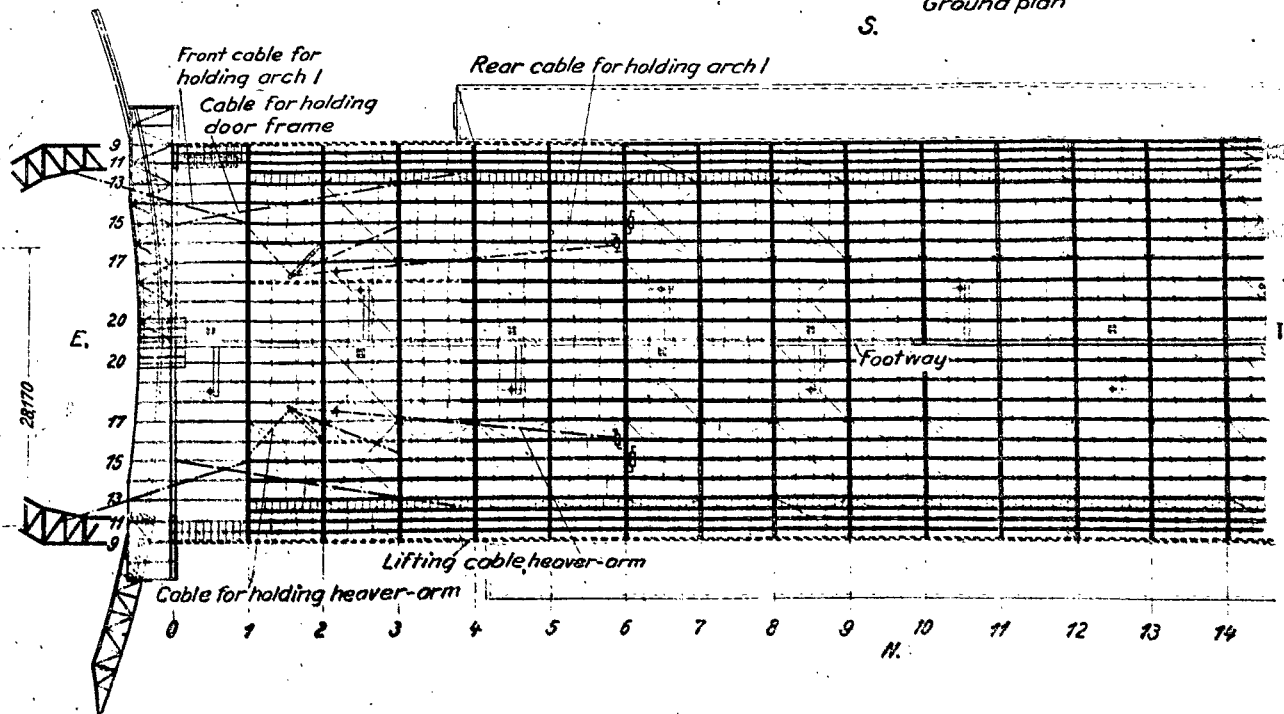
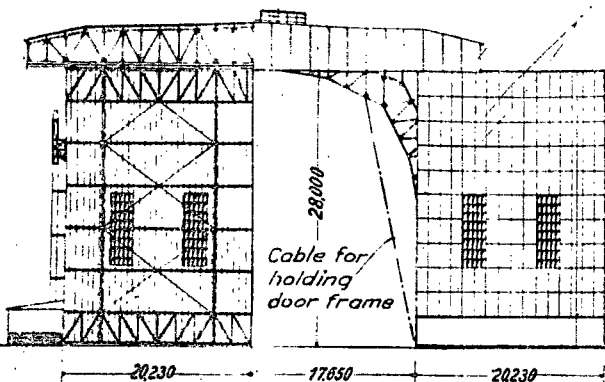
The roof covering had been partially removed. The roof supports were three-jointed arches with ridge-pole joint and buttress joints. Fig. 1 shows all the structural parts which had not been removed at the time of the collapse. There had already been removed both end-doors and guides, all supports between purlins 9 and 9, and the longitudinal brace in the side walls as far back as arch 7 and in the rear as far forward as arch 17. Under the roof covering, between arches 2 and 3, the cross-braces between purlins 17 and 17 had been removed and it is highly probable that all of them had been loosened. Of the

longitudinal girders between the upper and lower arches, all the upper members between purlins 13 and 13 had been loosened and the lower members were mostly bent and twisted by the weight of the upper members which, with their braces, were tilted and hanging sidewise. Lastly, the ridge-pole and the footway under it had been removed to about the middle of the shed, so that the ridge joint was no longer braced laterally. The buttress joints still held, because the walls below them were lined with masonry and the stays had not been removed.

In the condition shown in Fig. 1, all the arches had been detached to such an extent that their security was endangered. Relatively small eccentricities of the columns or spans or of the lateral forces could have easily caused them to break down. A strong gust of wind would have perhaps sufficed. The most endangered points, namely the top ends of arches 1 to 3, were subjected to considerable additional stresses, since heaver-arms were attached to the side of arch 2 for lowering the pur-

lins. These arms must have exerted bending stresses on the arches, the effects of which would increase, as more purlins were removed. One of the men, who was working on a heaver-arm after most of the purlins had been removed, escaped with his life, though not without severe injuries. He remembered that the top of arch 2, just before the collapse bent toward the end of the shed. This arch, in falling, brought down the others with it.

On south side, braces 20-22 and 17-25 entirely removed  
 " north " " 20-22, 17-25 and 15a "  
 " south " at 15-a, upper braces loosened  
 " " " 13-28, top member "  
 " north " " 13-28, " " "

The shed would probably not have collapsed if the wrecking had been done by a regular German construction company, preferably by the same one that built the shed, or even if it had at least been announced to the building authorities, so that it could have been officially supervised. One or the other course would certainly have been followed if the wrecking had been entrusted to German building authorities, instead of to foreign laymen.

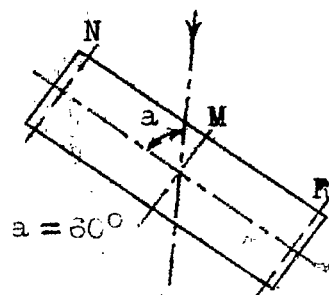
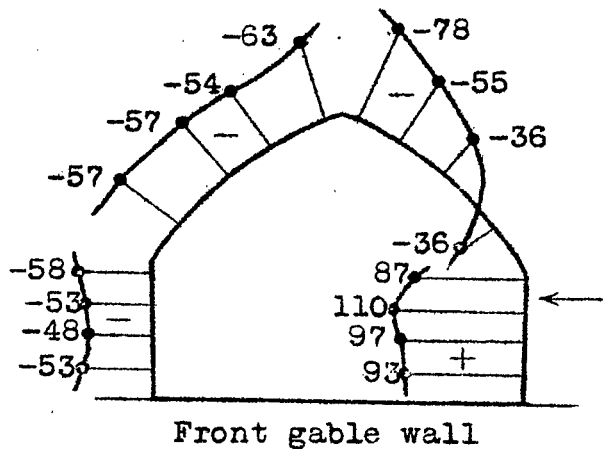
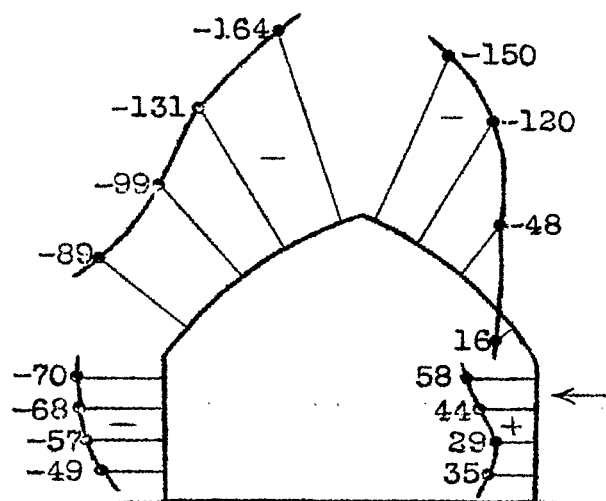
Fig.2 Air pressure distribution on model of airship shed, according to Eiffel. Plate XXXI of Atlas

without. The Staaken shed, in fact, had air-pressure, equalizing valves, but their effect was insufficient. Plate XXIX of Eiffel's Atlas (Fig. 2) gives wind-pressure distribution diagrams, which may be used here for comparison.

Fig. 2 shows the distribution of the pressure on the middle section and on the front gable wall of a shed model, created by an air stream with a velocity of 40 m/sec striking it at an angle of  $60^{\circ}$ . Toward the gable wall, on the windward side of the roof, the negative pressure decreases somewhat, though the manner of distribution is not changed.

It is seen that the location of the plates blown off is at the point of greatest suction and that their weight per square meter corresponds to the negative pressure in the Eiffel diagram. We may therefore conclude that the wind had a velocity of about 40 m/sec at the time of the disaster.

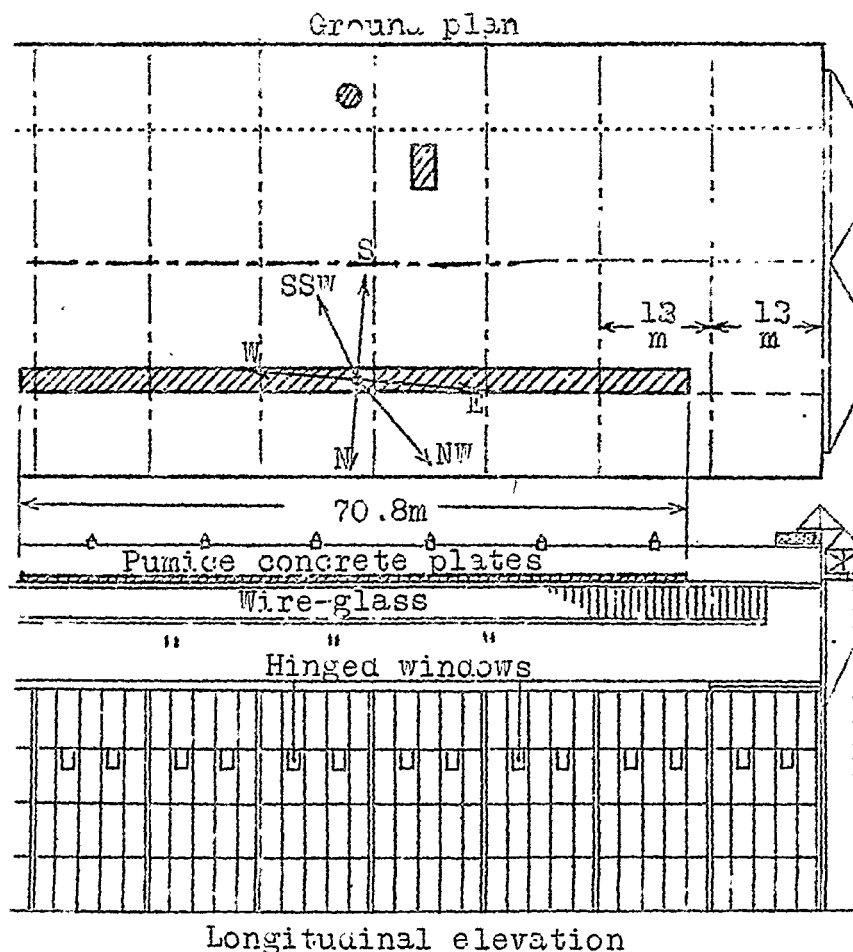
46 broad and 38.4 high, with an intervening shed 16 meters high, there still remained the latter and the north airship shed. This was covered partly with glass and partly with plates or slabs of pumice concrete (see Figs. 3 and 4).

The storm struck the airship shed at an angle of somewhat less than 45 degrees, tore off a row of concrete plates about 70.8 meters long half-way up the roof, blew them over the ridge-pole and deposited them on the shed in the lee of the airship shed. The distance the plates were carried varied between 45 and 60 meters.

Fig. 3 Ground plan and longitudinal elevation of damaged portion of airship shed "Nord" in Staaken. The cross hatching indicates damaged portions of shed roof.

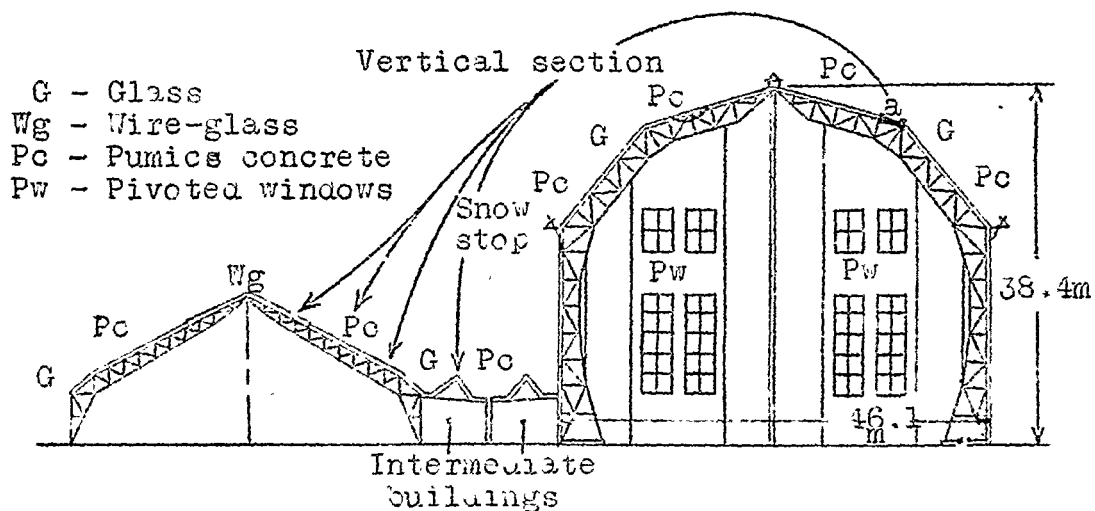
Each plate measured 2.36 x 0.6 meters, thus having a surface area of 1.416 square meters. With a unit weight of 80 kg, this gives a weight of about 57 kg per square meter. The total weight of the plates torn off is about 10,000 kg.

Fig. 4 Storm damage to airship shed "Nord" (right) in Staaken Dec. 18, 1921. Middle shed on left. At "a" the concrete plates were torn off by the storm.
